1. REPORT DATE (DD-MM-YYYY) 20-05-2004		2. REPORT TYPE Final Report		3. DATES COVERED (From - To) 15 August 2002 - 14-Jul-04	
4. TITLE AND SUBTITLE Degradation of Mechanical Properties of Multi Perforated Structural Elements				5a. CONTRACT NUMBER FA8655-02-M4052	
				5b. GRANT NUMBER	
				5c. PROGRAM ELEMENT NUMBER	
				5d. PROJECT NUMBER

Degradation of Mechanical Properties of Multi-Perforated Structural Elements

Re: SPC 02-4052

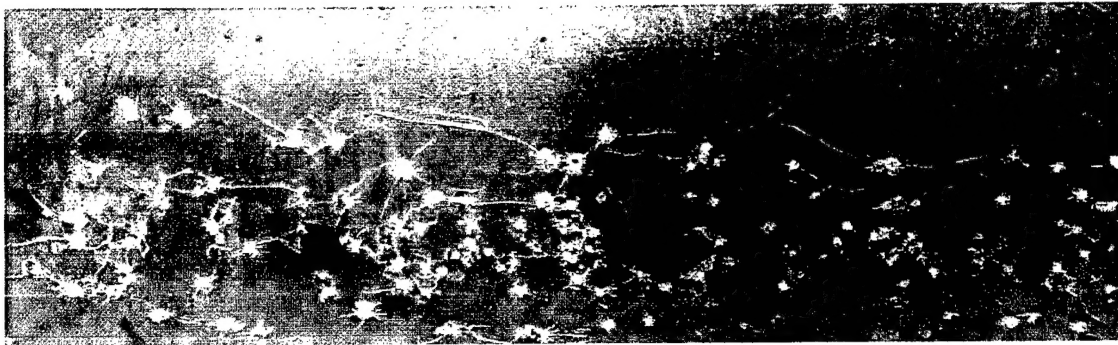
Serial Number	Damage Description
1	No perforation, even of the front, thin, PMMA layer. Craters and cracks only. Some of the fragments were embedded in the front layer and the rest fell off it
2	
3	Full perforation of the front, PMMA layer. The fragments stopped at the glue, bonding the two layers. The inner, PC, thick layer was cracked, probably due to the impact of large pieces of the charge and not by the actual fragments. Intensive de-lamination.
4	
5	Some of the fragments perforated both layers, causing shallow craters (~ 2mm) in the aluminum witness plates. Long range, cooperative cracking in both layers, but more intensive in the front, PMMA layer.
6	
7	Perforation of both layers and of the 6mm aluminum witness plate, and ~2mm craters in a second witness plate. Only short range cracking of both layers around the penetration holes. The PC shows a certain degree of dilation around the penetration holes, so that they were partly closed, but not sealed.

Figure 3 – The damage to sample 1 in test 1 (serial no. 1)

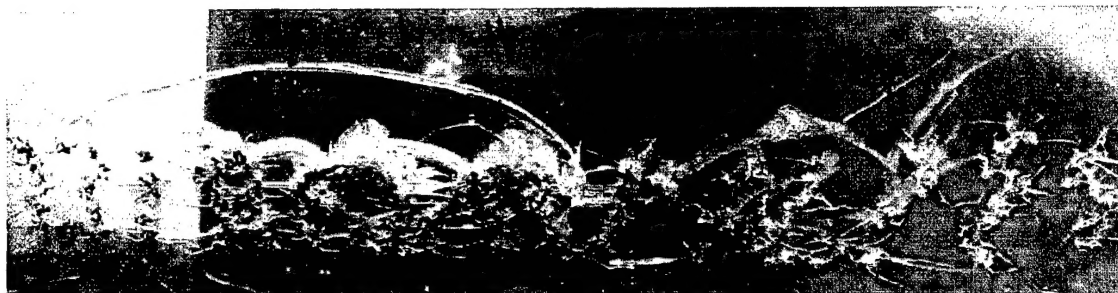
Figure 5 – The damage to sample 3 in test 1 (serial no. 3)

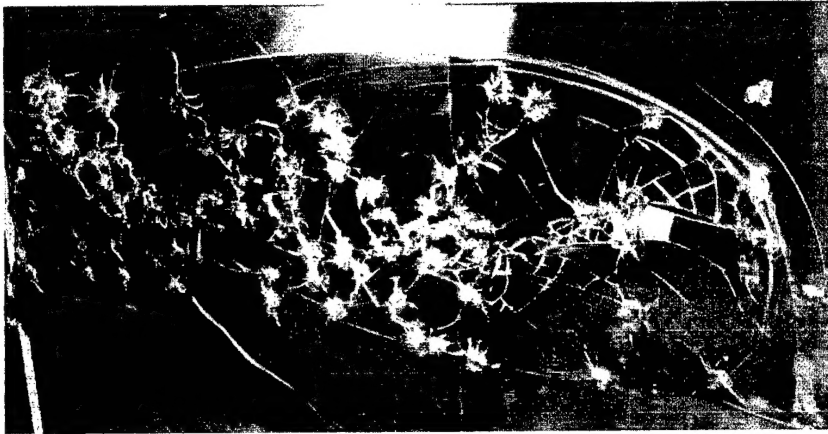
Figure 6 – The damage to sample 1 in test 2 (serial no. 4)

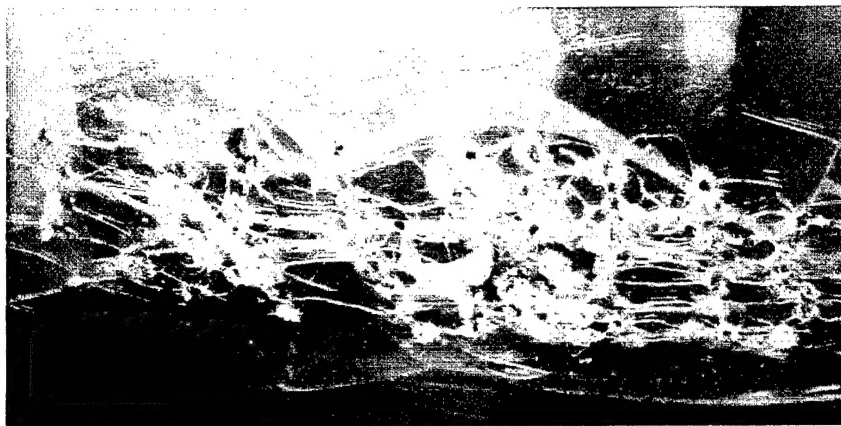
Figure 7 – The damage to sample 2 in test 2 (serial no. 5)

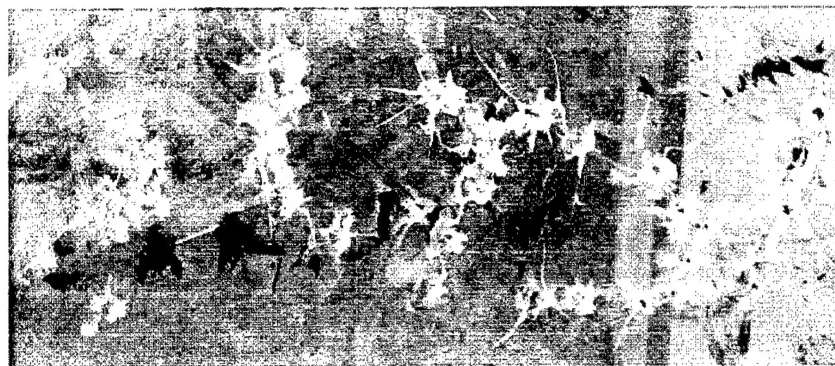
Figure 8 – The damage to sample 3 in test 2 (serial no. 6)

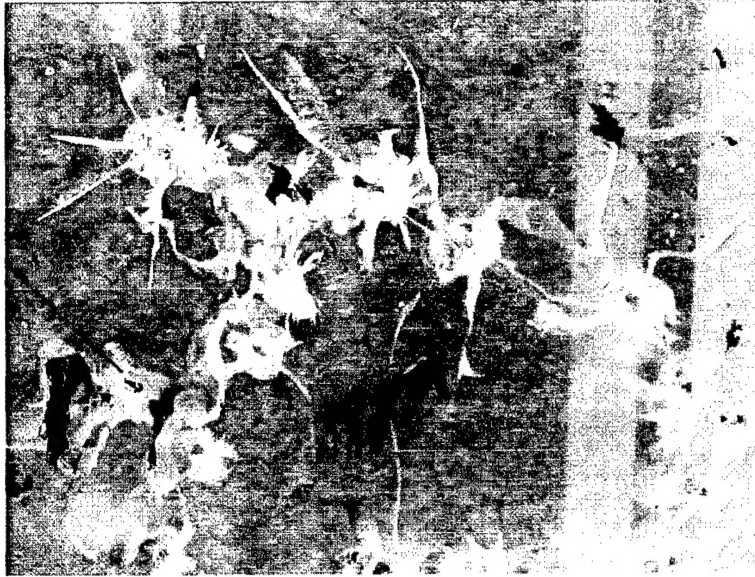
Figure 9 – The damage to sample 3 in test 2 (detail, serial no. 6)

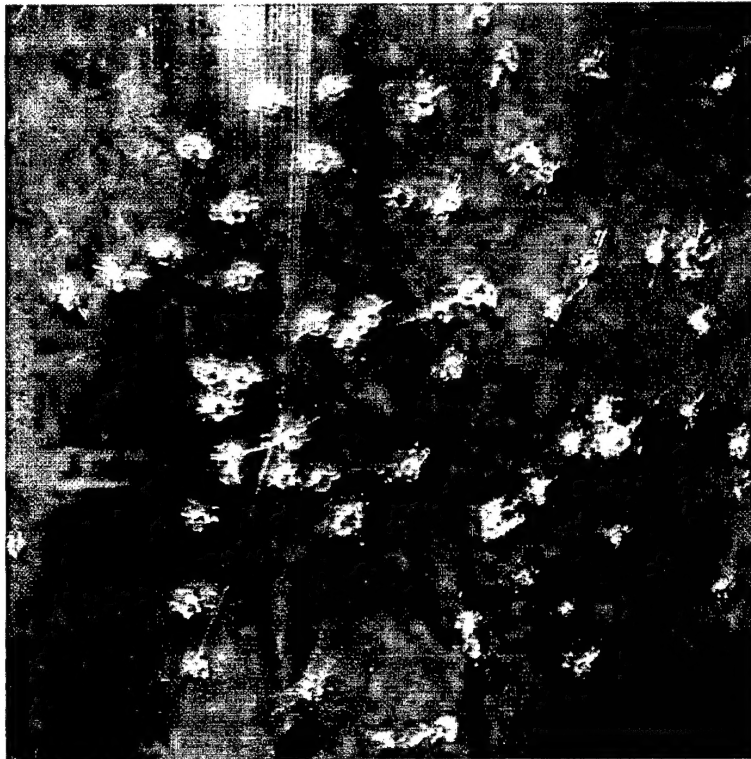
Figure 10 – The damage to sample 1 in test series 3 (1.6 m, serial no. 7)

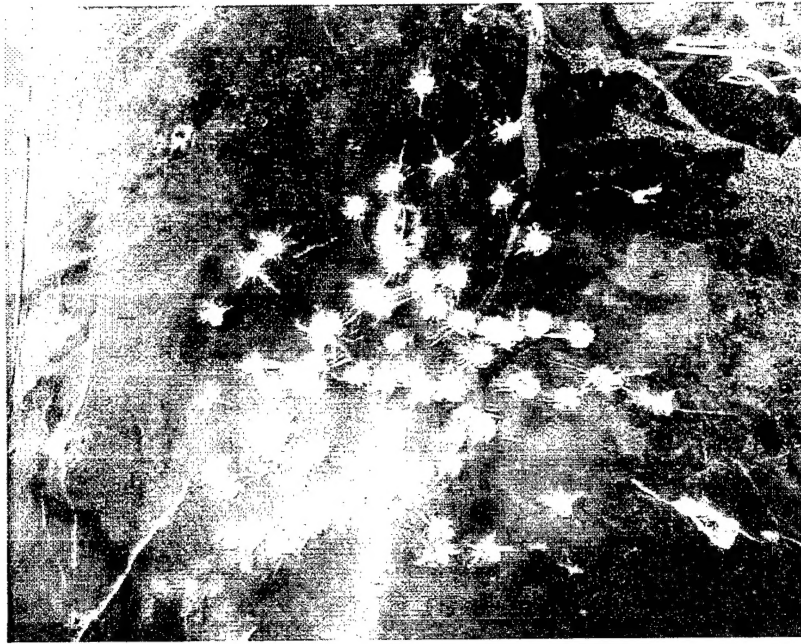
Figure 11 – The damage to sample 2 in test series 3 (1.3 m, serial no. 8)
